# PILKINGTON

## NSG Group Flat Glass Business

In the Spring of 2008, Image Resource Group was selected by Pilkington Glass for full turnkey implementation of North American locations in support of global rebranding initiative.

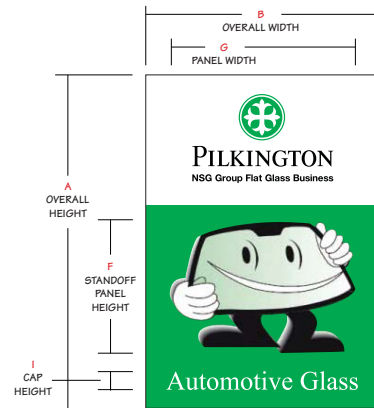
**PILKINGTON** Existing Signage: N02  
NSG Group Flat Glass Business Proposed Signage: PIL-WS-TERTIARY-HE-11 Address: 3440 Centerpoint Drive, Columbus, OH Site: Columbus(NC) ID #: PIL-132

**N02 East Elevation**  
Existing Signage: None  
Existing Fascia: Material: Dryse  
Condition: Clean and in good repair  
3M Fascia Color: T80  
Fascia Restoration: None

**SPECIAL CONDITIONS**  
Electrician required to run new conduit.

**PIL-WS-TERTIARY-HE-11** 170.50 sq.ft.  
Material: Flat Glass Sign Cabinet finished and mounted to an Aluminum extruded frame system. Frame to have a 1.25" RA Aluminum Back Panel.  
Each Sign Frame or Frame section needs to be assembled with the appropriate number of braces and compression support tubes in accordance to manufacturers recommendations. Corners to be reinforced with corner angles.  
Every Component to be Powder Coated on the Top / Bottom / and Sides Returns to the specified color.  
Graphics to be 3M Vinyl applied to the first surface.

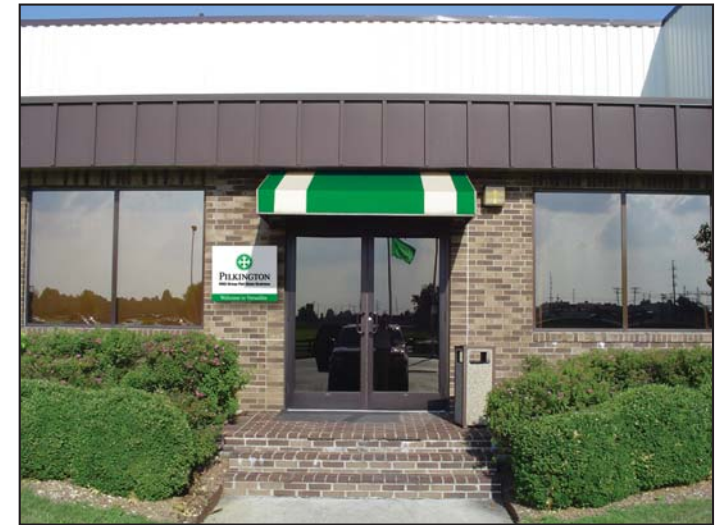
**PILKINGTON** Existing Signage: N04  
NSG Group Flat Glass Business Proposed Signage: PIL-WS-RECEPTION-2 Address: 102 Kuhlman Ave, Versailles, KY Site: Versailles ID #: PIL-021

**N04 West Entrance**  
Existing Signage: None  
Existing Fascia: Material: Aluminum  
Condition: Clean and in good repair  
3M Fascia Color: T80  
Fascia Restoration: Level of Restoration TBD by Actual Site Conditions.

**SPECIAL CONDITIONS**  
Recover Aiming to match Corporate Colors.

**PIL-WS-RECEPTION-2** 4.71 sq.ft.  
1 1/8" Thick, Extruded Panel to be mounted to building fascia.  
Background panel to be white powder coated.  
Graphics and Green Band to be 3M Vinyl applied to first surface.

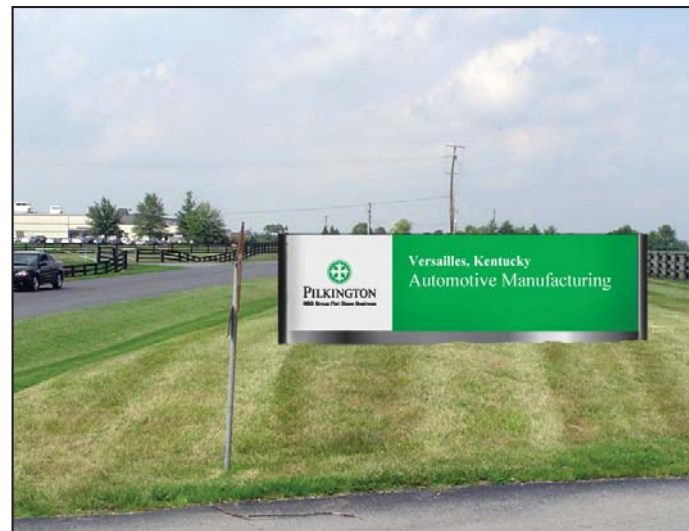
**PILKINGTON** Existing Signage: N01  
NSG Group Flat Glass Business Proposed Signage: PIL-M-APPROACH-HORZ Address: 102 Kuhlman Ave, Versailles, KY Site: Versailles ID #: 021

**N01 West Elevation**  
Existing Signage: Material: Dryse  
Condition: Clean and in good repair  
3M Fascia Color: T80  
Fascia Restoration: Level of Restoration TBD by Actual Site Conditions.

**SPECIAL CONDITIONS**  
No Specials Conditions for this Location.

**PIL-M-APPROACH-HORZ** 56.60 sq.ft.  
Two (2) Fabricated Aluminum Panels mounted between two (2) extruded aluminum corner posts. Alum. Panels to be 1/16" Thick.  
Panels to be bolted together, reinforced in between with vertical supports attached to each panel with 3M double side tape.  
Panels to have a 3/16" wide extruded cap (top and bottom).  
Every Component to be Powder Coated on the Top / Bottom / and Sides Returns to the specified color.  
Sign to have an Aluminum fascia plate at base.  
Graphics to be 3M Vinyl applied to the first surface.
